# Manhole Inspection Summary

Manhole # S67S\_\_010MH

Insp Date: **4/9/08 11:43 AM**

**Location** Address: **6401 Danville Ave.**

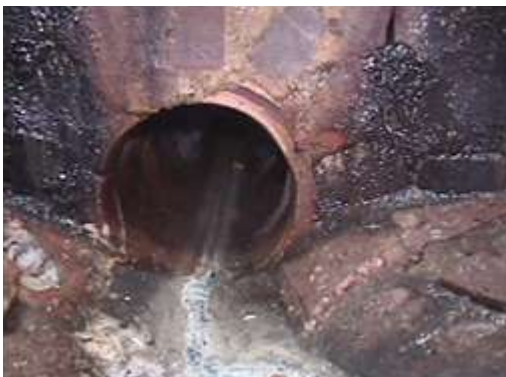
Defect 8

grease or tar build up around 12oclock outgoing pipe

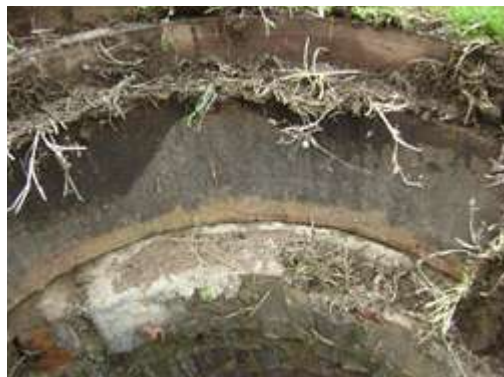
Defect 3

infiltration of roots--chimney/frame

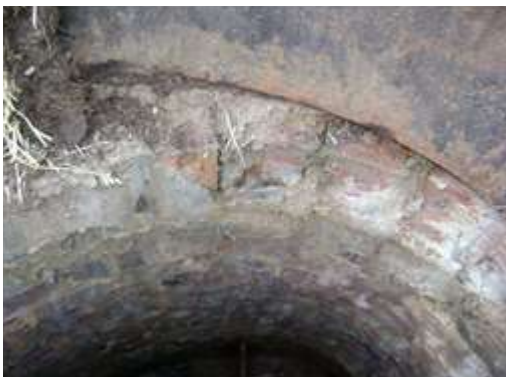
Defect 4

Condition: ☐ Sound ☐ Cracked ☐ Root Intrusion ☒ **Loose Brick** ☒ **Deteriorated**

Deterioration chimney/frame

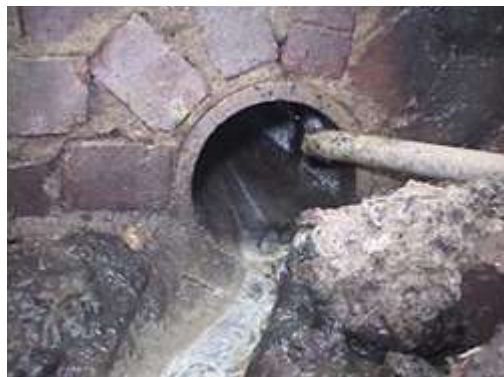
Defect 7

piece of pipe intruding in 3oclock incoming pipe

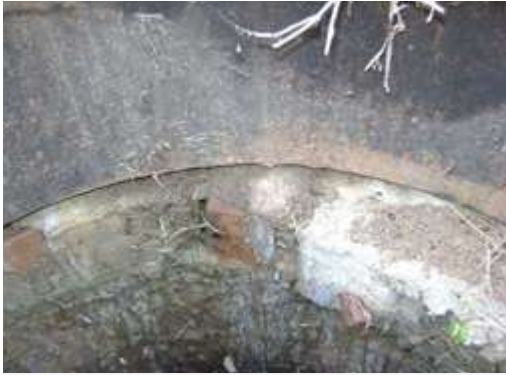
Defect 5

Loose bricks chimney/frame

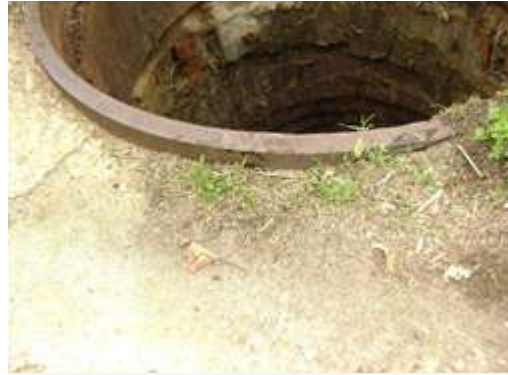
Defect 2

Above grade. cover

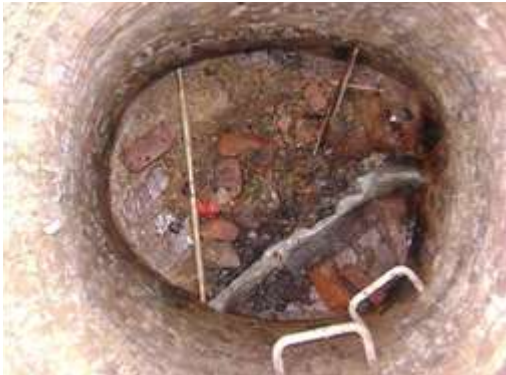
Defect 6

Deterioration and debris of bench.

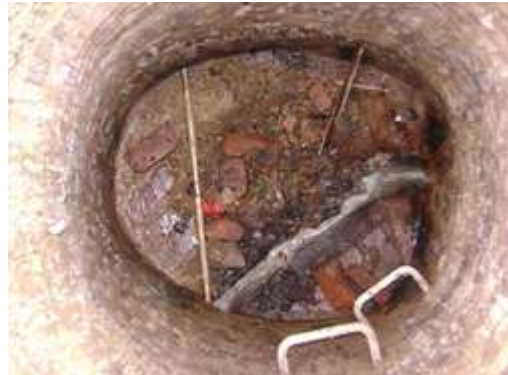
Defect 1

Condition: ☐ Sound ☐ Cracked ☐ Root Intrusion ☐ Deteriorated ☐ Leaks ☒ **Debris**

Debris in channel.

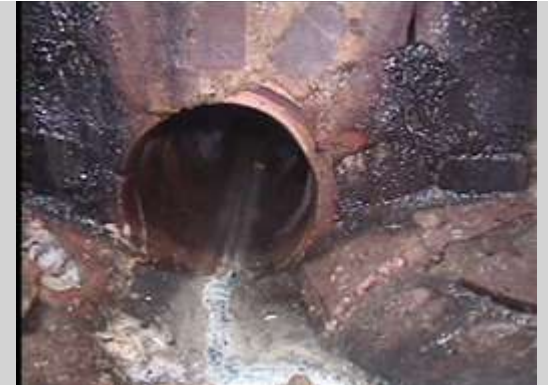
12 O'Clock Outflow

Pipe Height: **8.4** (in.) Rod and Bar (Angled)  
Pipe Material: **Clay** ☐ Pipe Lined  
Invert Depth: **7.92** (ft.) Flow Characteristics: **None**  
Deposits: ☐ None ☐ Mud ☐ Sludge ☒ **Debris** ☐ Grease  
Silt Depth: **0.5** (in.) Deposits Extent: **Light**  
Infiltration: **None** Pipe Seal Cond: **Sound**

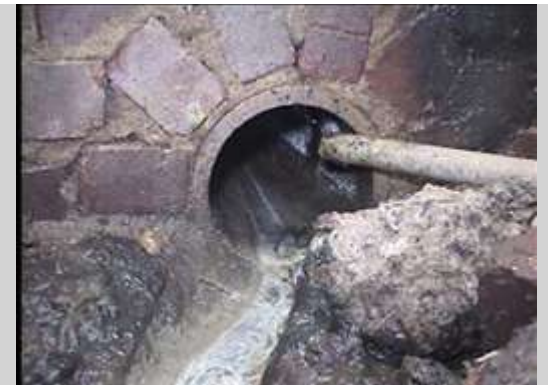
3 O'Clock Inflow

Pipe Height: **6** (in.) Rod and Bar (Angled)  
Pipe Material: **Clay** ☐ Pipe Lined  
Invert Depth: **7.50** (ft.) Flow Characteristics: **None**  
Deposits: ☐ None ☐ Mud ☐ Sludge ☒ **Debris** ☐ Grease  
Silt Depth: **2** (in.) Deposits Extent: **Heavy**  
Infiltration: **None** Pipe Seal Cond: **Sound**
